# **Mobile Pentium® II Processor Specification Update**

Release Date: June 1999

Order Number: 243887-011

The Mobile Pentium® II processor or the Intel® Pentium® II Processor Mobile Module may contain design defects or errors known as errata which may cause the product to deviate from published specifications. Current characterized errata are documented in this Specification Update.

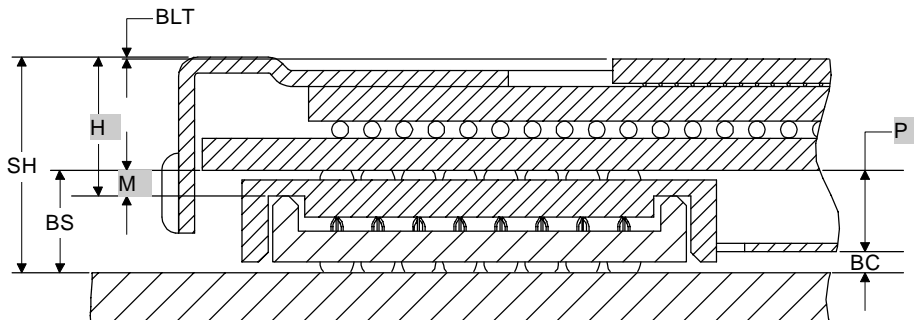
Figure 5.6. Cross Sectional View with Vertical Dimensions

### B1. Misabeled Vertical Dimension Parameters

Figure 5.6 in the *Mobile Pentium® II Processor at 233 MHz, 266 MHz, and 300 MHz* datasheet should be replaced by the following figure:
